Troubleshooting and Tech Tips

TROUBLESHOOTING AND TECH TIPS INDEX FROM TECH UPDATE BOOKS - 2002 THROUGH 2010

2011 Technical Update Book — Sea-Doo PWC and Sport Boats

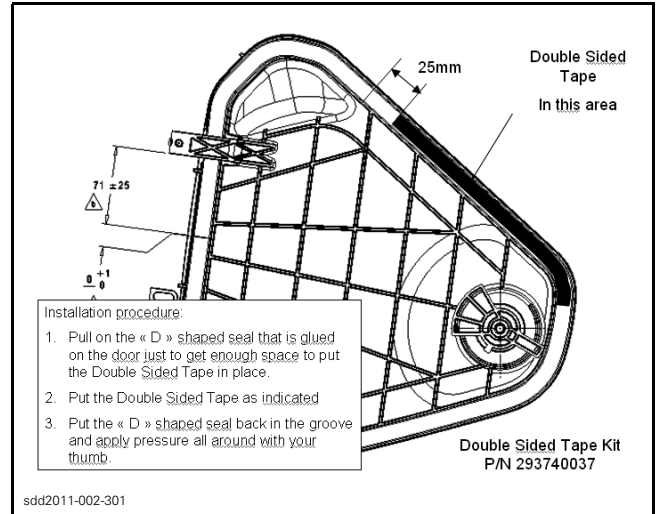
Some iControl fixed deck models may have a gap between the access panel and the hull when fully closed. In certain extreme riding conditions or uncovered mooring situations during very heavy rains, some customers may experience what they feel is unacceptable leakage from the rear access panel seals. A Double Sided Tape Kit (P/N 293 740 037) has been developed to address the issue, however it must be understood that these panels are not designed to be water tight in submersed conditions. Always keep unattended watercraft covered.

Double sided tape kit P/N 293 740 037.

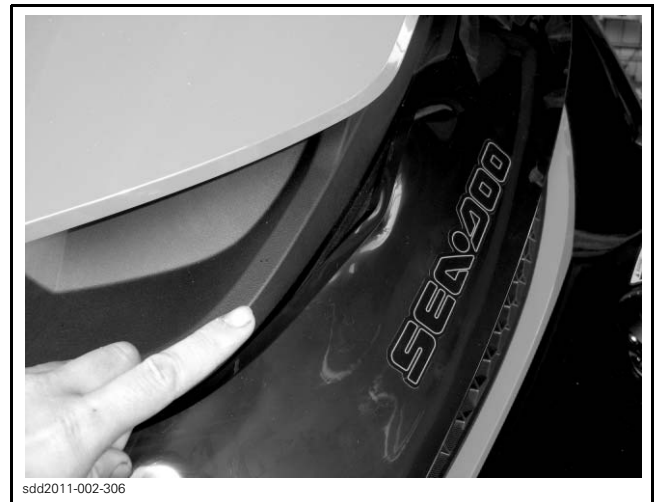
FRONT PANEL MELTING AND DEFORMING

It is critical when uncrating a Sea-Doo Watercraft, to take the unit out of the shipping bag or protective wrap as soon as the top of the crate is removed. We have found that if the unit is left inside the enclosed bag with exposure to the sun, temperatures can rise to significantly high levels. This increase in temperature may be hot enough to start to melt and distort the plastic hood. Please make sure your PDI team is aware of this communication.

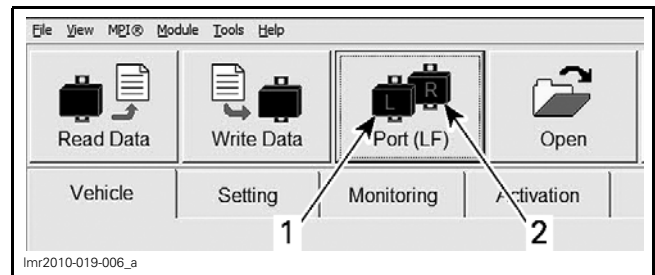
210 and 230 Challenger Sea-Doo Boats have iTC (intelligent throttle control) along with two engines and two ECMs that can communicate with each other through the CAN network. The wiring harnesses are identical so there are two diagnostic connectors but it makes no difference which one is used when connected to B.U.D.S. However, when connected you must choose what engine/ECM you want to communicate with. This can be done by choosing the R or L icon as shown below.

1. Port (L) ECM selected
2. Starboard (R) ECM available
