Troubleshooting and Tech Tips

TROUBLESHOOTING AND TECH TIPS INDEX FROM TECH UPDATE BOOKS - 2002 THROUGH 2010

2011 Technical Update Book — Sea-Doo PWC and Sport Boats

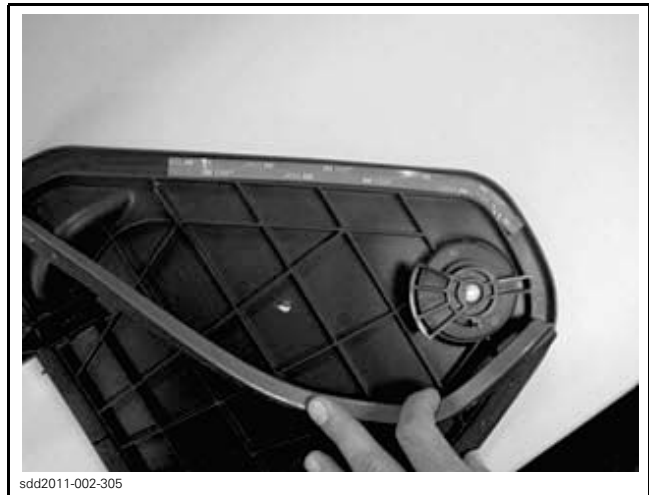
Some iControl fixed deck models may have a gap between the access panel and the hull when fully closed. In certain extreme riding conditions or uncovered mooring situations during very heavy rains, some customers may experience what they feel is unacceptable leakage from the rear access panel seals. A Double Sided Tape Kit (P/N 293 740 037) has been developed to address the issue, however it must be understood that these panels are not designed to be water tight in submersed conditions. Always keep unattended watercraft covered.

Reinstall the "D" shaped seal back in the groove and apply pressure all around with your thumb.

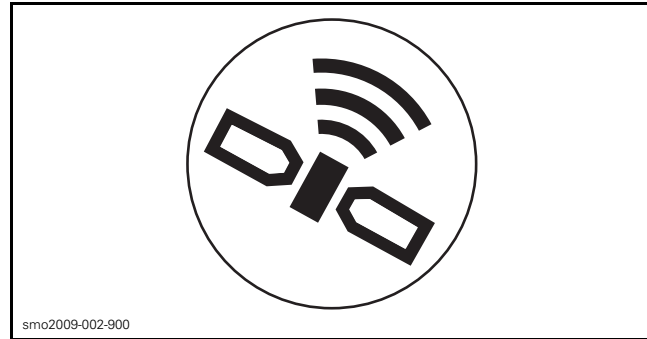
Because the clock, altimeter and compass functions on iControl craft's are set thru the GPS, the craft must have a satellite signal for these to operate. The clock time in hours can be set if needed, as stated in the owner's manual, but the minutes can not be altered.

Care must be taken when troubleshooting a cluster related issue, and keep in mind that the issue could be caused by a failed satellite signal to the GPS. Most of the time troubleshooting is performed inside a shop environment and it is likely the GPS **WILL NOT** get a signal indoors.
